**Performance Audit:  
Department of Watershed Management  
Automated Meter Reading Program**

**December 2007**

**City Auditor's Office  
City of Atlanta**

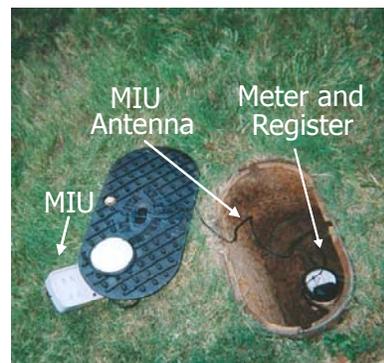
**Figure 1  
AMR Components**

The water meter measures the volume of water that customers use. That use is recorded on the attached register – a device like an odometer. A meter interface unit (MIU) is attached to the water meter and collects water use data from the register (see figure 1). Using radio frequency signals, the MIU electronically transmits the data to either a handheld or mobile data collector (see figure 2). The

antenna attached to the MIU enables the data collectors to receive the radio signals. This information is then transferred to the department's billing system.

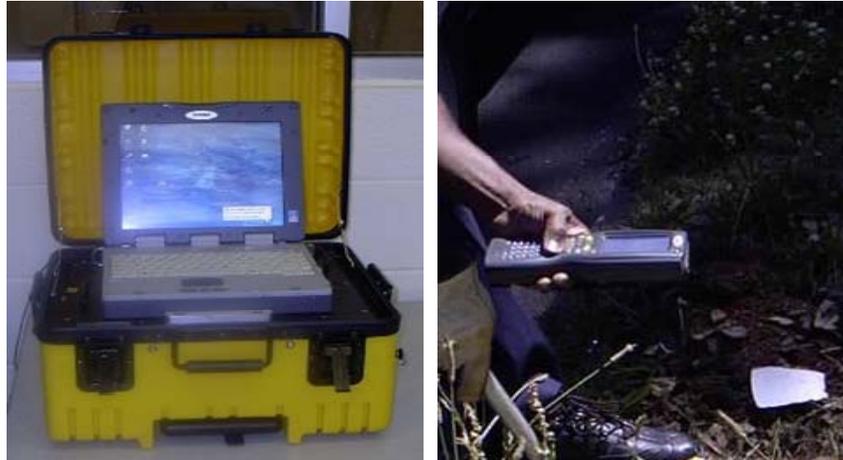
Mobile Data Collector

Handheld Data Collector

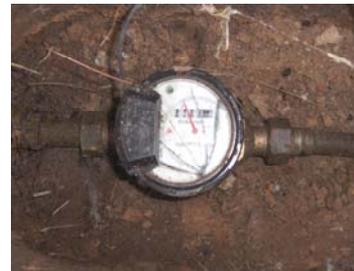
**Figure 3  
Cracked Meter Register**

**About 9% of meter registers were cracked; half of these were inoperable and need to be replaced.** Of the 138 meters sampled, 12 (8.7%) had damage to the meter register; in 6 of these cases the register was not operating (see figure 3). While it is not possible to identify when and how the meters were damaged, this level of damage to newly installed or retrofitted equipment suggests the department will face ongoing challenges maintaining the system.

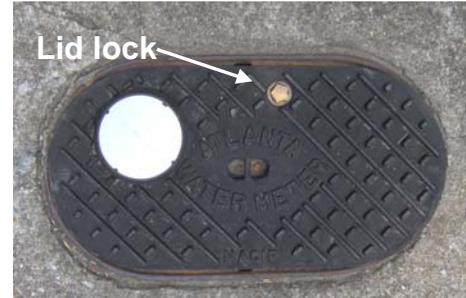
**Figure 4  
Locking Meter Lid**

**More than 70% of the meter lids were unlocked.** K&V is contractually responsible for replacing meter box lids with locking lids that have no holes to let water into the box. Project staff told us that the meter lids should be locked to prevent public access to the equipment. Only 39 of the 138 sampled meters were locked when we arrived at the meter site; 99

(72%) were unlocked. While it is not possible to know whether a K&V installer failed to lock the lid after installation, a city inspector left the lid unlocked after inspection, or a homeowner unlocked the lid, failure to lock the lid exposes the equipment to possible tampering or damage. We observed one meter interface unit in which the wires connecting it to the register had been cut. The meter installers and inspectors should ensure that the lids are locked.

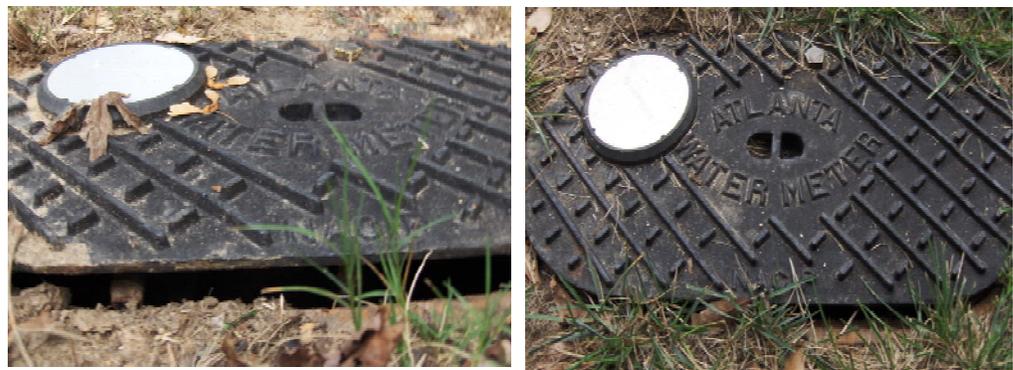
**Figure 5  
Lids That Do Not Fit Meter Pits**

**About half of the meter sites sampled need new meter boxes.** The city is responsible for replacing meter boxes when they are broken, plastic, or when the lids do not fit properly. Of the 138 meters sampled, nine (6.5%) meter boxes were plastic, six (4.4%) metal meter boxes were damaged, and an additional 53 (38.4%) had lids that did not fit the box.

Because of installation placement, plastic meter boxes (see figure 6) increase the likelihood of damage to the meter reading antenna, while damaged boxes increase the likelihood of damage to the meter register itself. Many of the meter sites we observed had noticeable gaps between the meter box and lid (see figure 5).

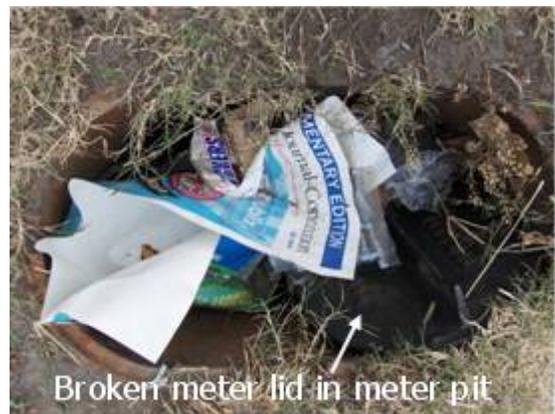
**Figure 7**  
**Broken Lid with Debris in Meter Pit**

Poorly-fitting lids potentially expose the equipment inside the meter box to water damage and debris, as shown in figure 7. Although the equipment is designed to function submerged in water, both circumstances could ultimately impair meter functionality.

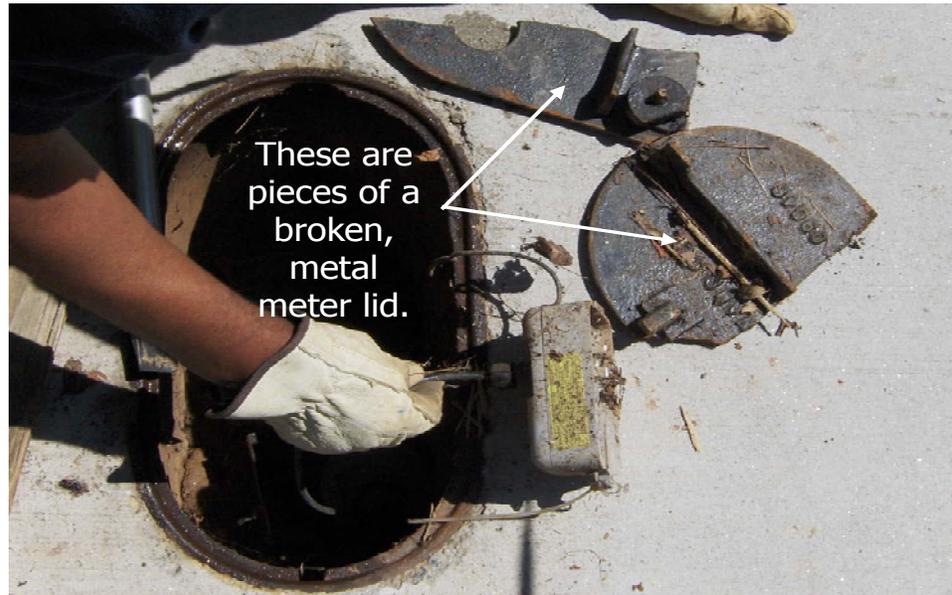
**Figure 8**  
**Broken Meter Lid**

We also noted five instances where the new meter lid was broken, which could pose a hazard as well as expose the equipment (see figure 8) to damage. Lids are not included under warranty. Some staff suggested that forcing the lids to lock onto ill-fitting meter boxes puts the lid under stress and allows it to break more easily.

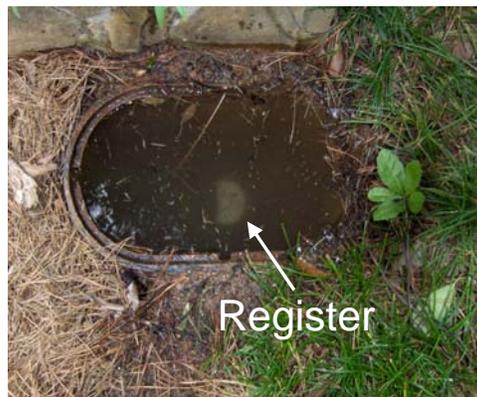
**Figure 9**  
**Meter Leak**

**Reliance on error codes and customer complaints is inadequate to identify maintenance needs in small residential meters.** AMR technology enables meter readers to collect reads by driving by the meter site, rather than collecting the data manually.

This approach reduces operating expenses but eliminates the visual inspection of the meter site that accompanied the manual process. Thus, the department may not be aware of problems, such as broken lids (see figure 8) or leaks (see figure 9) that are wasteful or potentially hazardous but do not generate an error code in the AMR system.

| <b>Recommendation:</b> | 5. Department officials should develop a maintenance plan for small meters that includes periodic site surveys or similar ways to identify operational problems – such as leaks and broken lids – that cannot be detected with AMR technology. | |

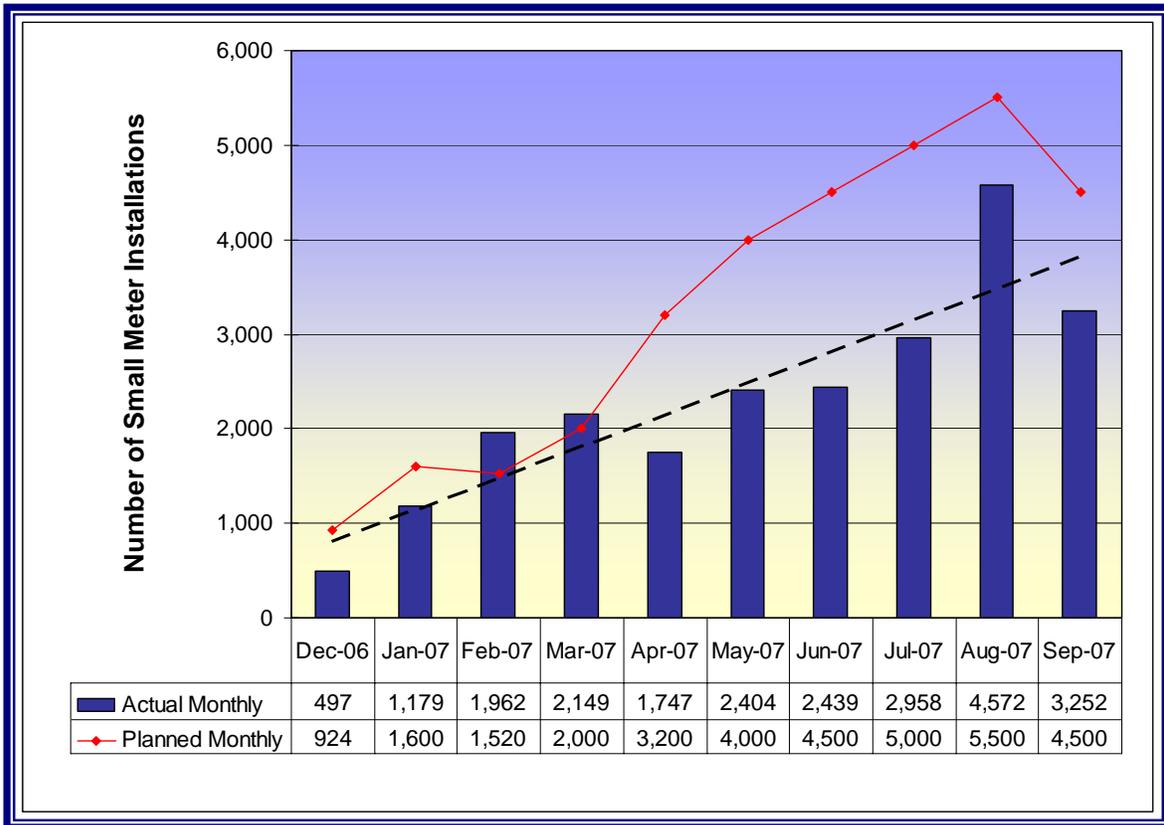
**EXHIBIT 7  
MONTHLY INSTALLATION OF SMALL METERS**

Although the contract with K&V was signed in July 2006, meter installations did not begin until the city's AMR pilot project began in December 2006. Full project implementation began in January 2007. As shown in Exhibit 7, K&V's small meter installation has fluctuated from month to month, but has increased over time as shown by the trend line. However, from December 2006 through September 2007, K&V met or exceeded the monthly installation goal for only two months - February and March 2007. The highest production month was in August 2007, with over 4,000 installations. But even then, the production level was still short of the installation goal of 5,500 meters for the month.

**Source:** Developed by audit staff with data from the department’s weekly reports. The planned installation figures were taken from the contractor’s original installation schedule (developed October 2006), provided by department staff.

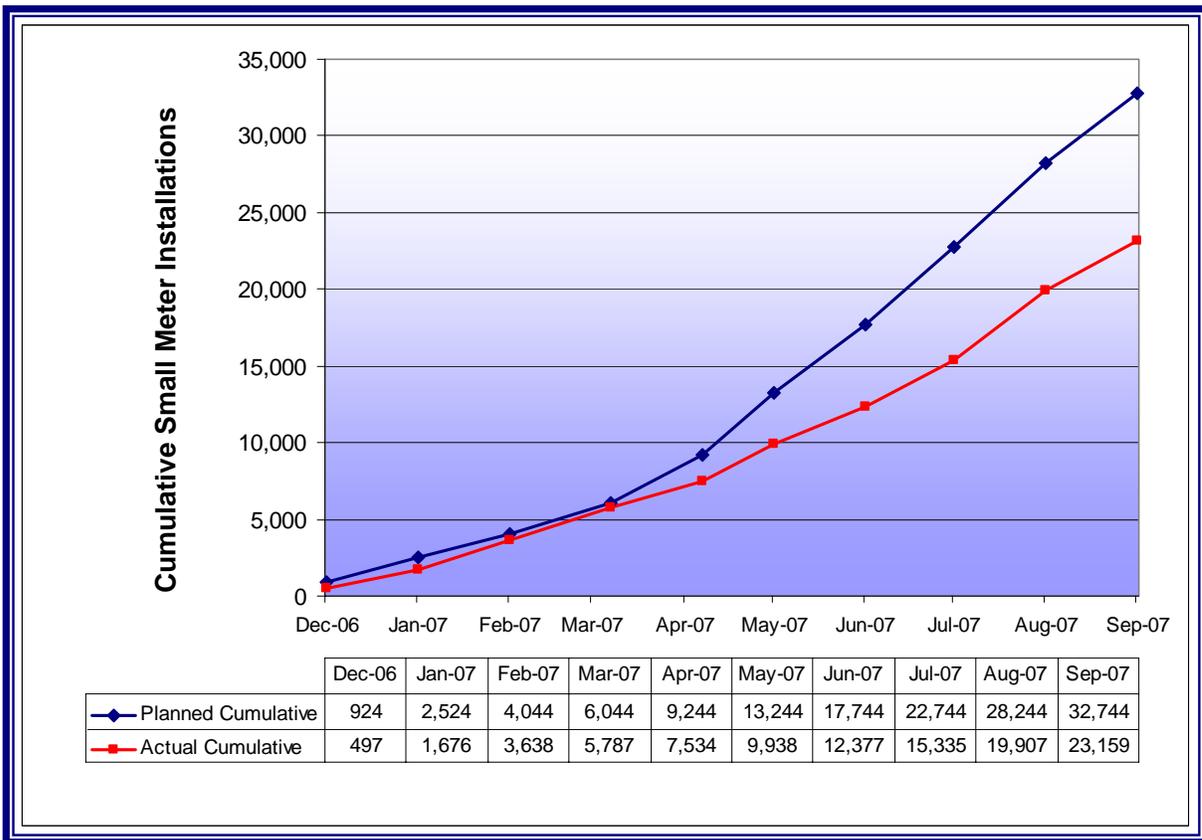
**EXHIBIT 8  
CUMULATIVE INSTALLATION OF SMALL METERS**

According to the city’s weekly reports and information provided by K&V staff, K&V’s production has been limited by staff shortages and high turnover among its installers. In April, K&V sent a letter to the city’s AMR project staff stating that their (then) backlog would be caught up by the end of September, and they planned to meet that goal by increasing staff. City staff responded to K&V in June stating that the contractor’s performance was at an unacceptable level, and stated that K&V would be held to the September goal. However, during the month of September, not only did K&V fail to meet the monthly installation goal, but as shown in Exhibit 9, their productivity decreased from the previous month. By September 2007, K&V was 9,585 meters short of the planned goal, as shown in Exhibit 8.

**Source:** Developed by audit staff with data from the department’s weekly reports. The planned installation figures were taken from the contractor’s original installation schedule (developed October 2006), provided by department staff.

| <b>Recommendation:</b> | 2. Department officials should impose available contract remedies, such as a 10% withholding of any current and subsequent invoices, to ensure the contractor's compliance with the contract's installation goals. | |

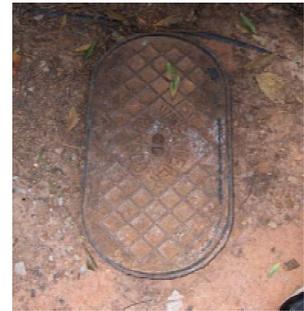
**Figure 10**  
**Old Meter Lid**

**K&V has been unable to provide an adequate supply of meter lids for AMR installations.** Although K&V ran short of the AMR lid inventory in July, they continued to install/retrofit meters, replacing existing meter lids (see figure 10) on the meters instead of the new AMR lids. At the beginning of September, city staff noted that there were approximately 6,000 meter installations done without the proper lids. In addition to the existing backlog of small and large meter installations, having to backtrack in order to install the AMR lids may put the contractor even further behind schedule.

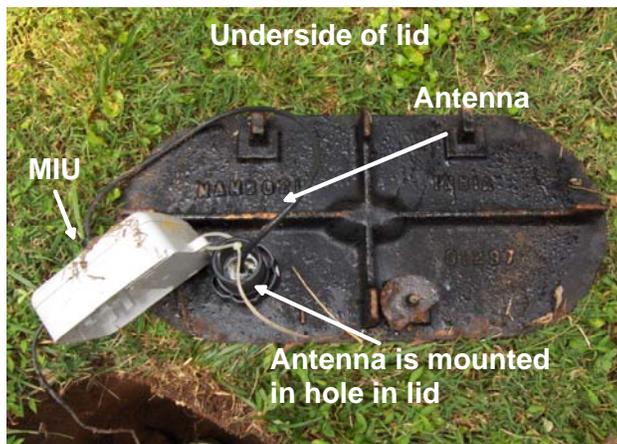
**Figure 11**  
**Mounting of MIU Antenna in Lid**

**AMR lids are necessary for maximum signal reception.** The AMR contract requires the contractor to install cast iron locking lids; the lid design was approved by the city. The system is configured to

obtain the maximum signal strength from the MIUs installed in the meter pits. The basic AMR system components include a water meter, register, and meter interface unit (MIU) with attached antenna. All components are manufactured by Neptune. Electronic

meter reads are transmitted via radio frequency (RF) signals. For maximum signal strength, Neptune recommends that the MIU antenna be mounted in a hole in the pit lid (see figures 11 and 12), which is designed for this purpose. Without adequate reception, the meter reader may not be able to obtain an electronic read, defeating the purpose of AMR.
